Title Transnational protection strategy for cultural heritage
Part 9 – Romania

Final version
12/2022

Author(s) ADRIANA PANAITE/INCDT

Project ID DTP3-1-359-2.2

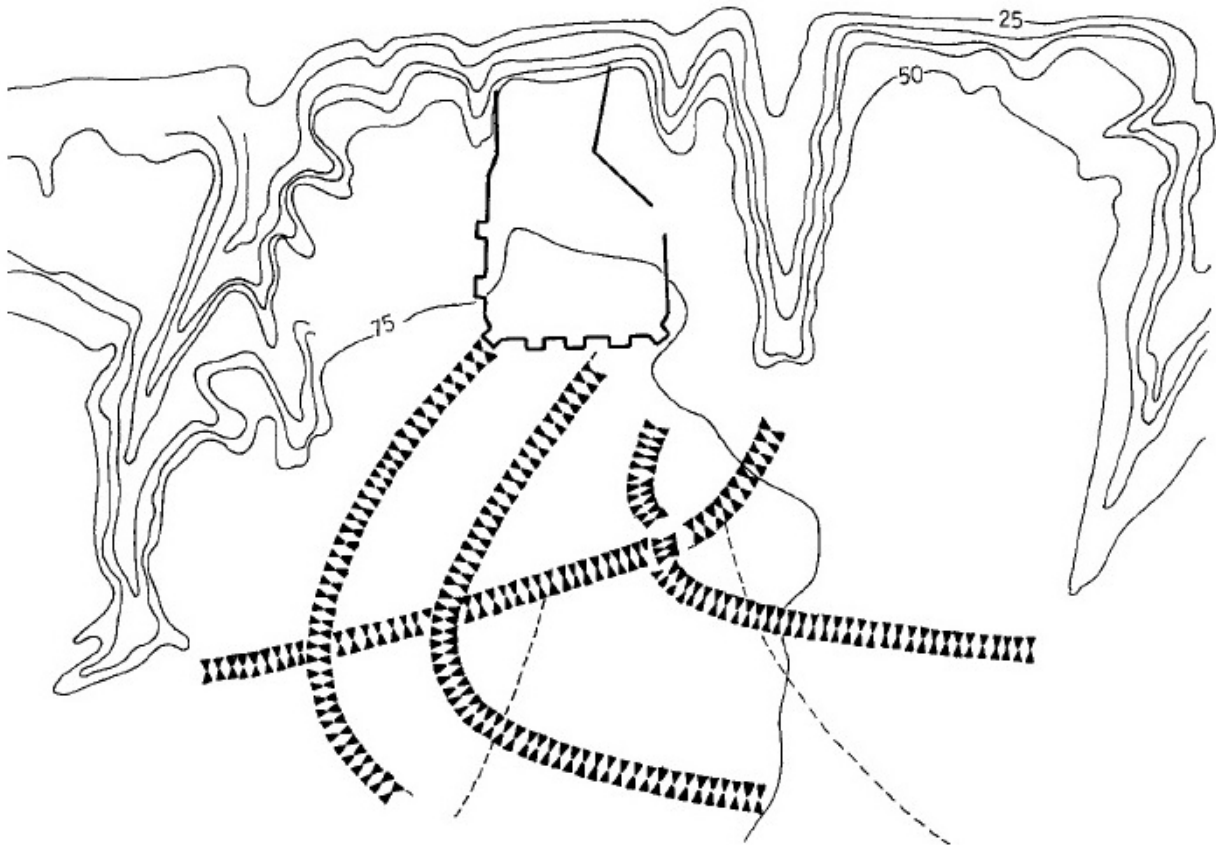
Site plan (map):

Plan of the site, after Scorpan, C., Limes Scythiae. Topographical and stratigraphical research on the Late Roman fortifications on the Lower Danube, BAR IS 88, Pl. XIX, Oxford, 1980, 164

The territory of Sacidava is part of an elongated rectangle, a flat plateau above the Danube bank, at an altitude of 60-78 m AA, approx. 20,000 square meters, which descends in a rapid slope to the Danube. The site is situated approx. 5 km NE of the village of Dunăreni. The access it is made on the county road DJ 223 and the communal road DC 51.

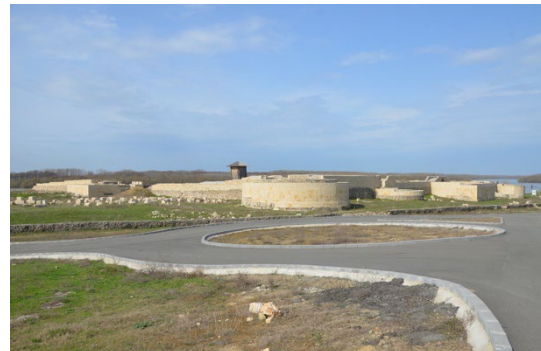
Figure 21: The east fan-shaped tower.

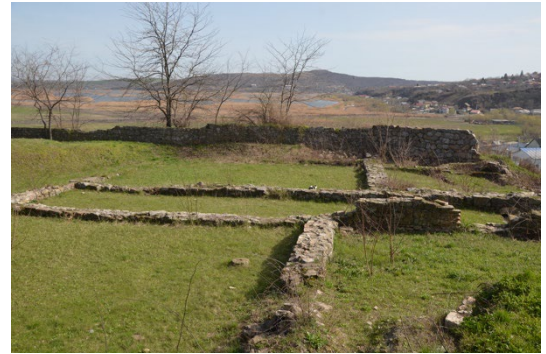
Figure 22: The Roman fortification Aegyssus, view to south.
