Title Transnational protection strategy for cultural heritage
Part 10 – Moldova

Final version
12/2022

Author(s) Ungheni City Hall
Iurie Cujba, Ina Olearciuc, Tatiana Talpă, Victoria Darie

Project ID DTP3-1-359-2.2

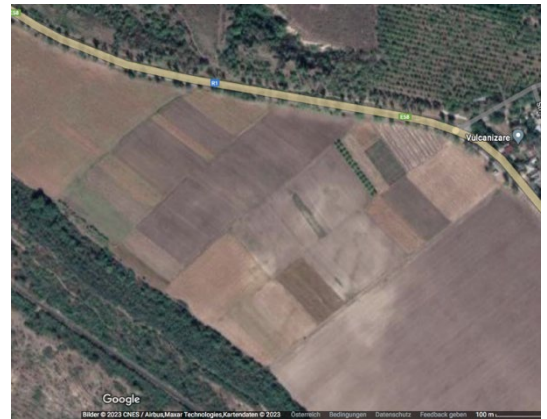
Figure 23; The site of Medeleni is used for agriculture.

The Roman necropolis of Medeleni was partly excavated in 2015 (rescue excavation) and dates back in the 3rd century. Aerial images show the cemetery near to the village of Medeleni, about 1 km north of the river Prut. The archeological site is not covered with modern building structures.
