Concept for a Summer University on Cultural Landscapes in Climate Change¹

(Intellectual Output 2 – CHePiCC online)

Bertolin, C. / Califano, A. / Schwai, M. (eds.) CHePiCC Summer School “Cultural Heritage Protection in Climate Change”. Trondheim, Norway. 30th May 2022 – 4th June 2022.

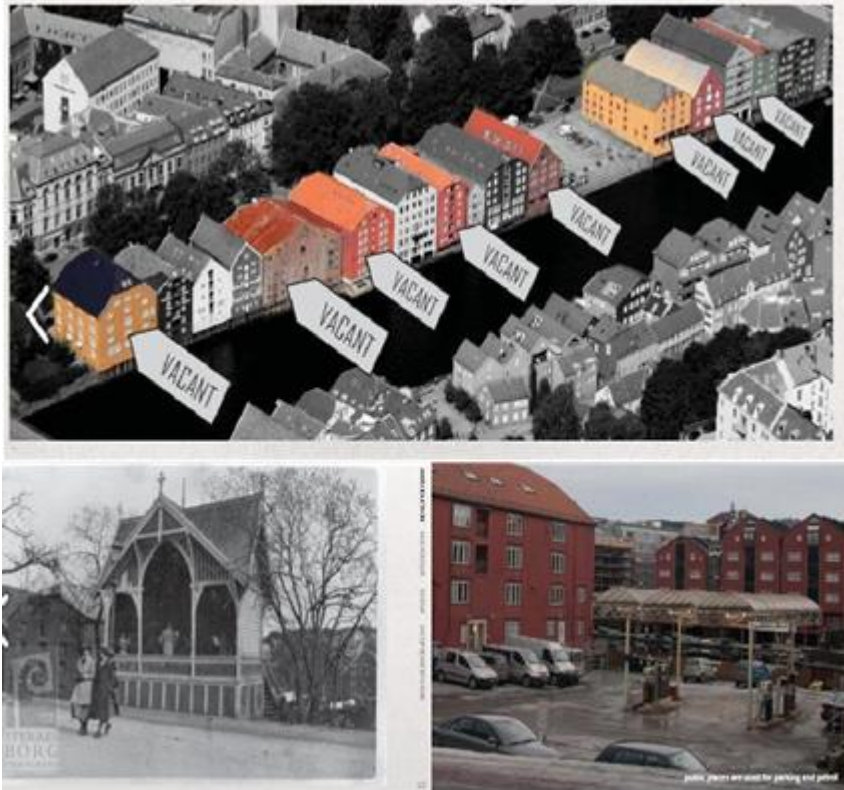
The Warehouses

The construction was the traditional technique of interlocking logs, with naked log-timber interior surfaces. When the shallow waters to the north of the city were dredged and protected by a sea wall in the early 19th century the insufficient harbour facilities were supplied with a necessary extension, and similar warehouses were built on the northern shore of the city, and later connected with the railway station on the artificial islands, forming another distinctive feature of the city-scape, the canal harbour. The original wharfs were not used as dwellings, but today, many have been converted into residential houses; this is however not permitted in the city side row along the river. Others are art galleries, coffee shops, restaurants, and boutiques. The cobbled walking paths make exploring the historic wharfs an easy and beautiful stroll. There are also several benches along the paths for those who want to relax. The Old Town Bridge over the Nidelven River is a great spot to get a picturesque view of the historic wharfs from a distance.

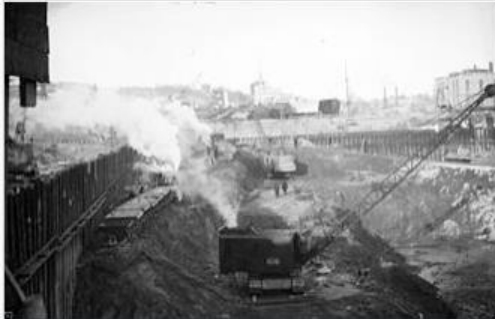
Construction of the bunker

The two German submarine bunkers, Dora 1 and Dora 2, from World War II were built at Nyhavna. Dora 1 was completed in the summer of 1943, while Dora 2 was never completed. Dora 1 was later converted into a warehouse and office building, and after the war Dora 2 was left to The Port of Trondheim. In 1943, Dora was bombed by the American Army. It was not damaged completely, while the buildings in the rest of the area around Nyhavna were badly damaged during the attack.

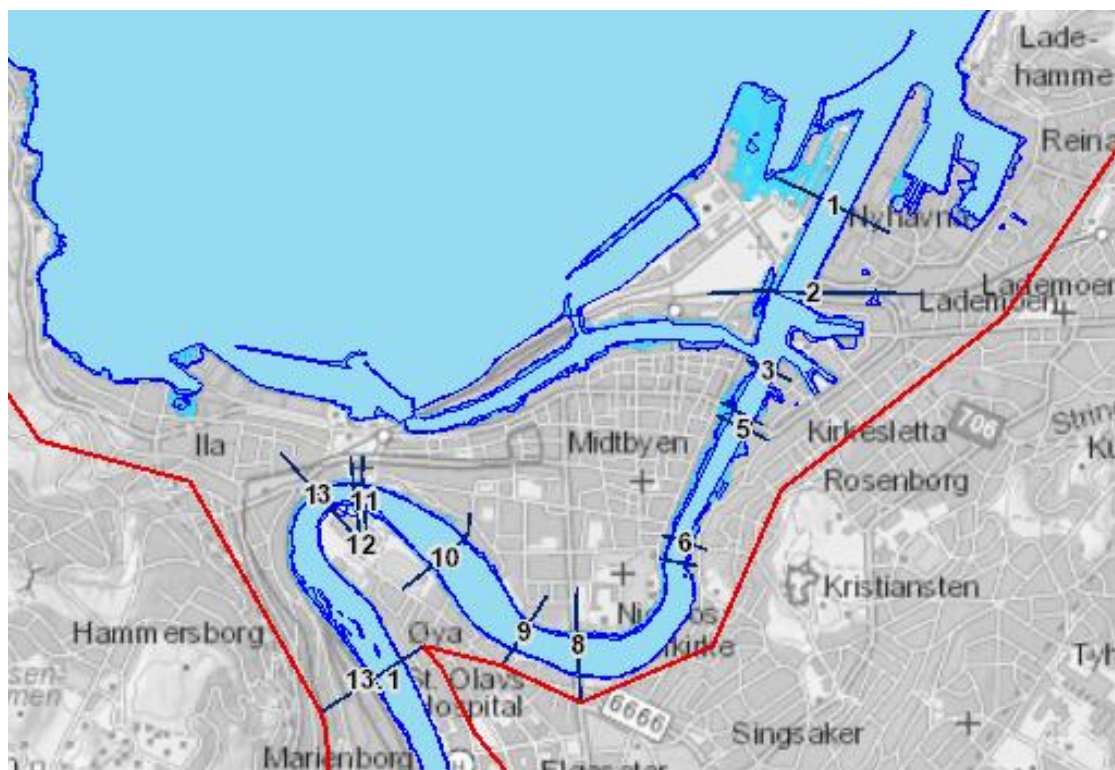
Figure 2: Flood zones in Trondheim (forecast in 2100). Flood data obtained from NVE, 2020

Warehouse, and the archive Dora I suffer periodic floods at least every 10 years. The high frequency of the events indicates that the floods in Trondheim are not caused by climatic extreme events. Floods usually occur in late winter, when heavy rainfall falls, and the ground and gutters are still frozen (Meiforth, 2017). For this reason, it is important to take preventive measures that prevent the deterioration of the affected heritage areas in the long term. Figure 6 also shows the square meters of the Dora 1 archive that have been affected by periodic flooding.

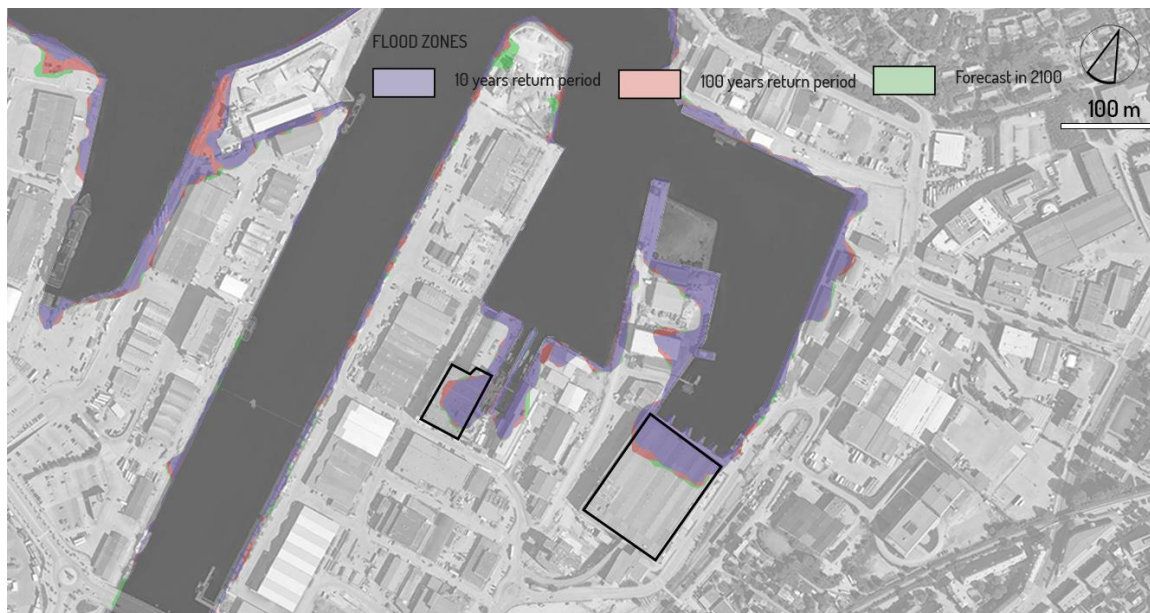
Figure 5. Flood zones near to Dora archives. Flood data obtained from NVE (2020).

As a re-action to the flood forecast (see figure 5 and 6), a waterproof wall that divides the internal structure is proposed as it is shown in figure 7 and 8 due to the fact that 23%, 29%, and 33% of the total floor area are endangered to be in flood zone in 10 years in return, 100 years in return, and 2100 in future forecast respectively.
