Title Transnational protection strategy for cultural heritage
Part 4 – Slovakia

Final version
12/2022

Author(s) MMPIB
Municipal Monument Preservation Institute Bratislava

Project ID DTP3-1-359-2.2

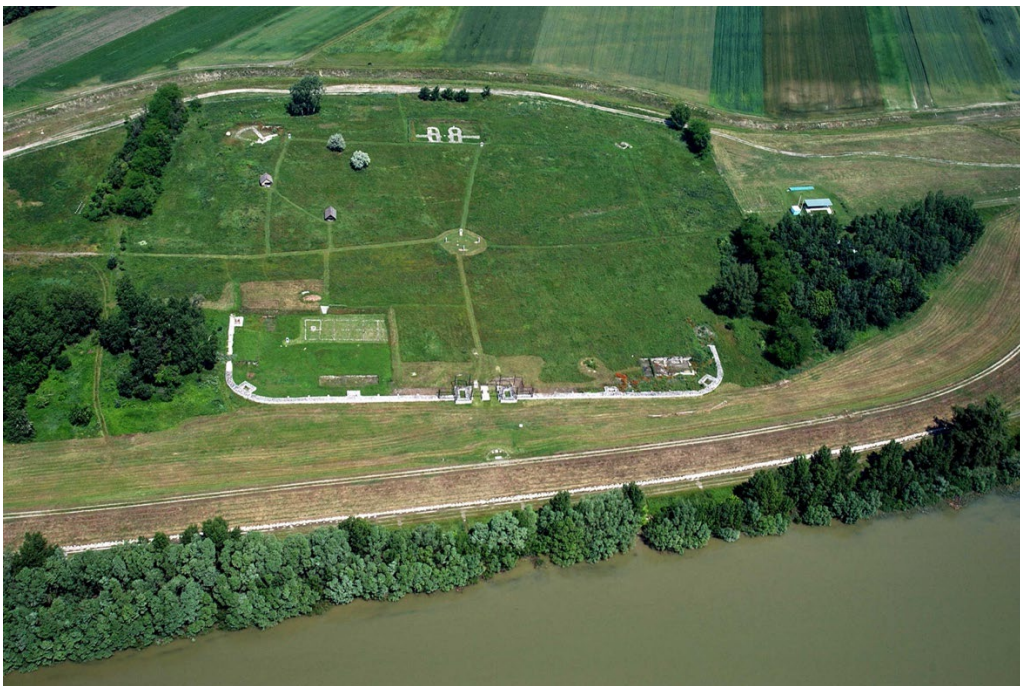
Figure 1 Fort of Iža, roman military camp, picture: ©Ján Rajtár

The first excavations were done by J. Tóth-Kurucz at the beginning of the 20th century. He examined a major part of the fort and produced its ground plan with fortification, headquarters, barracks, stables, stores, granaries and bath in the inner area. During the further excavations in the middle of the 20th century (B. Svoboda) were discovered the north-east corner tower with the late extension of a fan-shaped floor plan from the 4th century there remain only the foundation ditches filled with debris and the east intermediate tower with two v-shaped ditches in forefront.

During the excavations of the Archaeological Institute of SAS since 1978 were uncovered the north gate with remains of horse-shoe shaped extensions from the 4th century, the north-west corner tower with remains of late fan-shaped extension and whole of the south part of the fortification with south gate, two intermediate and two corner towers. In the south-west quarter of the fort were the outlines of foundations of barrack building from the end of the 2nd and the first half of the 3rd centuries as well as three wells and the remnants of two large bakery ovens excavated. In the

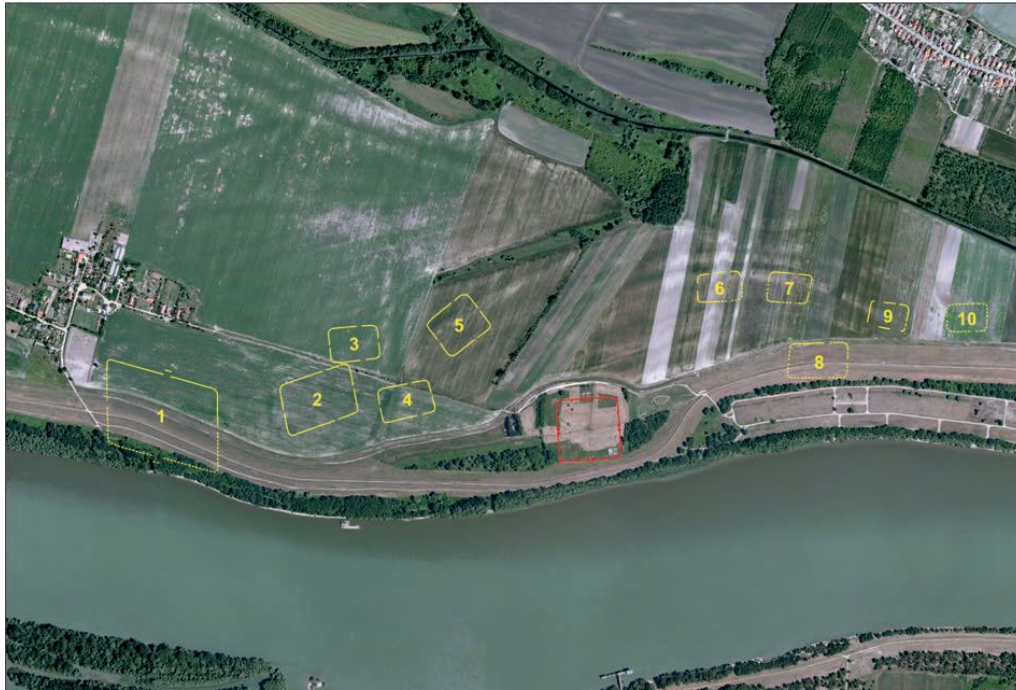
Figure 2 Temporary camps around the Iža fort. Picture: ©Ján Rajtár

The main risk could be flood caused by the river Danube and field works not only for the fort, but also for the temporary camps found nearby.

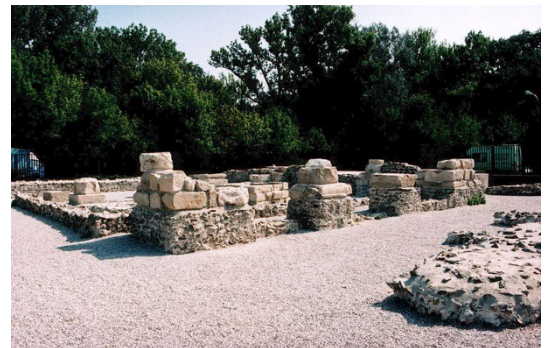
Figure 8: Remains of the Burgus.

The remains of the Roman fort, vicus and necropolis are located in Bratislava-Rusovce, 15 km south of Bratislava, approximately 1,5 km away from the river Danube. During excavations, the remains of Roman structures have been partly uncovered and restored/reconstructed, so that they can be visited today. Other areas are still underground and covered with modern superstructures. Geophysical surveys have been completed in these areas. The oldest building phase, a wooden fortress, goes back to the year 81 CE (founded under Domitian), the most recent building phase in form of a late antique fortress dates back between 375-380 CE.
